HOUSATONIC RIVER BASIN  
STOCKBRIDGE, MASSACHUSETTS

GLENDALE DAM  
MA 00021

PHASE I INSPECTION REPORT  
NATIONAL DAM INSPECTION PROGRAM

JULY 1979

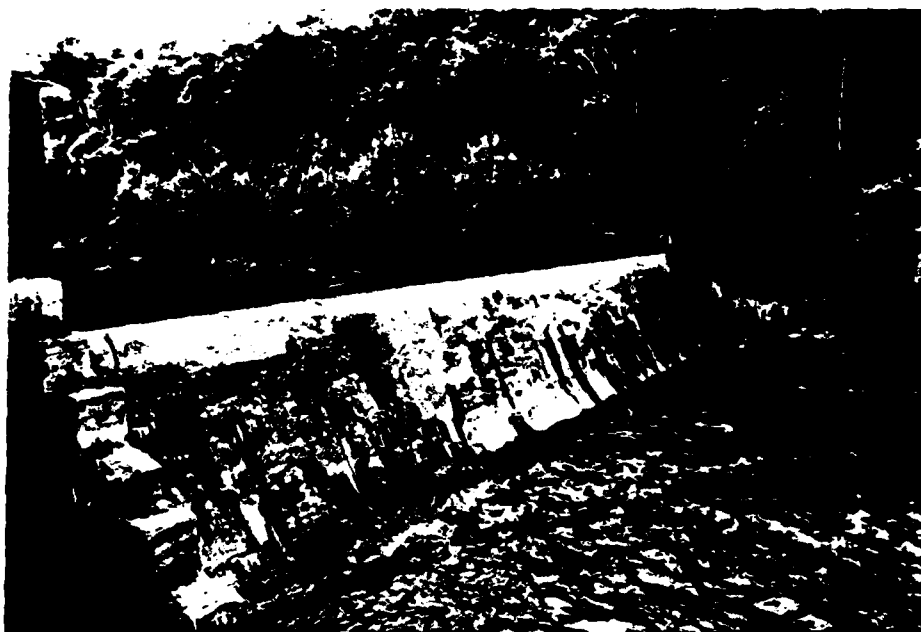
1. Overview of Glendale Dam spillway structure

b. Dam. The main dam is a concrete ogee spillway structure. The downstream face of the spillway has extensive spalling and surficial erosion throughout the full length of the dam, Photo No. 1. Extensive surface cracks were observed. The second joint from the right abutment has extensive erosion at the tailwater level, Photos No. 1 and 3. The first joint to the left (about 19.5 ft.) from the left abutment is leaking from a level about 16 ft. below the spillway crest, Photo No. 4. There is an eroded horizontal cold joint on the upstream face of the spillway about 4.5 ft. down from the weir crest, Photo No. 5, which runs for the major length of the spillway. Observations made during the preliminary reconnaissance of the dam indicate several other eroded horizontal cold joints exist below this elevation.

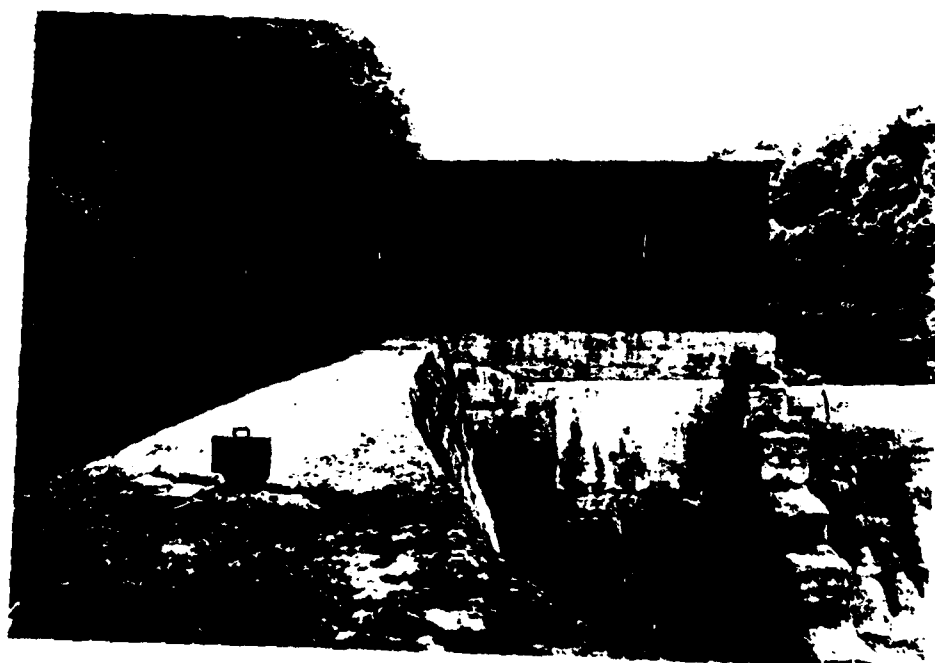
2. Gatehouse above waste-way and power channel outlets

The gatehouse is a timber building seated on the dam, Photos No. 2, 5 and 7. The framing and sheathing are in good condition. The exterior finish is stained wood shingles which are in need of restaining. The roof was not observed, but no signs of leaking were in evidence. The window panes have been replaced by movable wooden enclosures. Three of the four wooden outlet gates are missing and the fourth, which is in poor condition, was in place and closed. The double-stemmed, manually-operated rack and pinion gate mechanisms, Photo No. 6, were not operable and appeared to be under repair. The wooden guides for the closed right power channel head gate are rotten and in poor condition, Photo No. 5.

The general condition of the concrete outlet structure is poor. There is extensive surficial deterioration on the downstream side above the waste gate openings, Photos No. 2 and 7. Extensive spalling, erosion of concrete, and a heavy amount of efflorescence were observed throughout this area. A deteriorated horizontal crack or cold joint was observed above the waste gate openings, the joints are in deteriorated condition, and there is a heavy brush growth on the concrete walls, Photo No. 7. The waste outlet training wall is also cracked, spalling and shows signs of efflorescence, Photos No. 7 and 8.

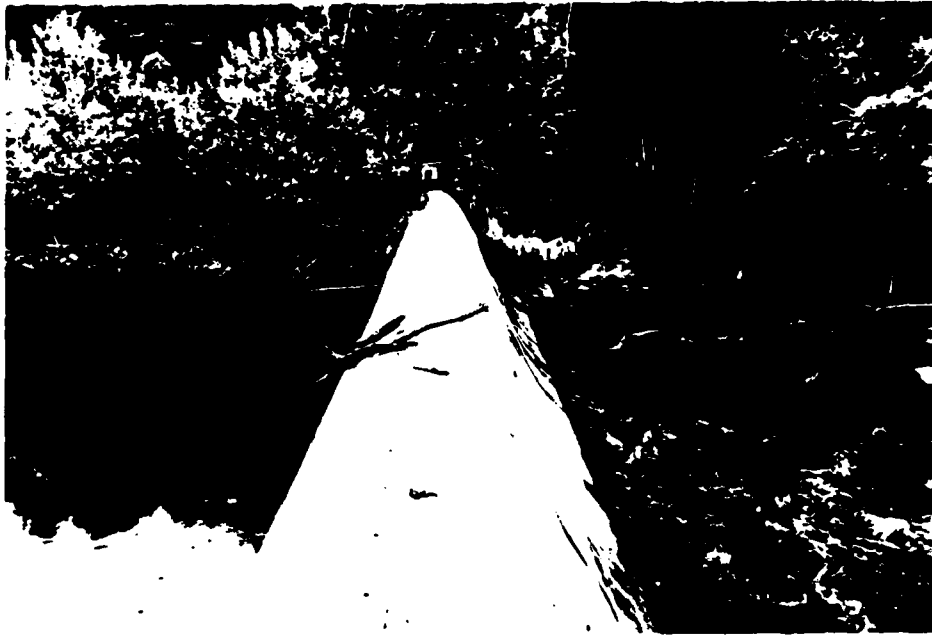
The right training wall (abutment) has extensive spalling and surficial erosion of concrete, Photo No. 7. There is extensive cracking and efflorescence of the gunited left training wall (abutment), Photos No. 3 and 4. There was a small amount of seepage observed at the base of the left abutment wall at the bedrock interface. The volume of seepage water is not more than 1 to 2 gallons per minute.

3. View along axis of spillway and left abutment

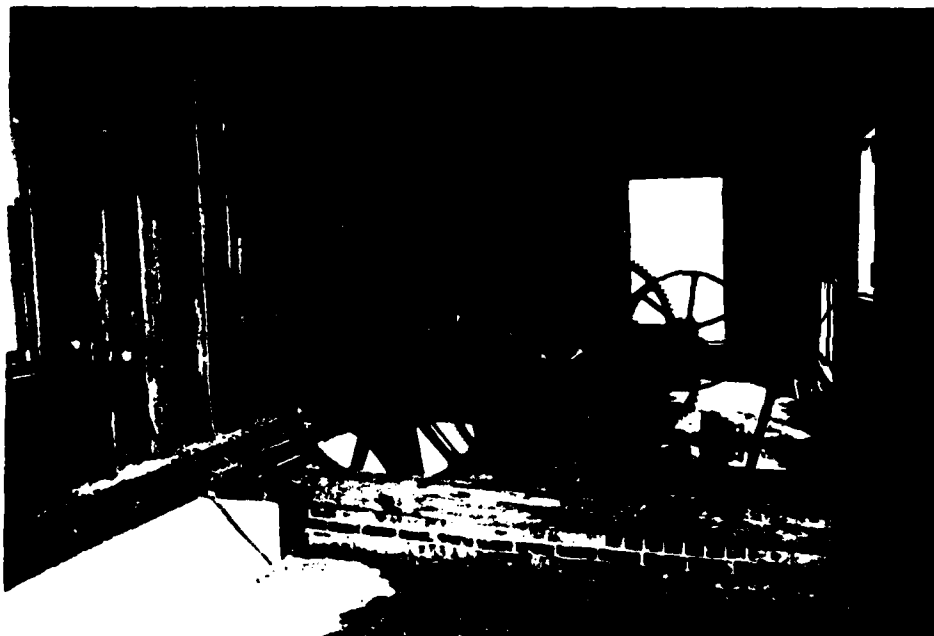
6. Gate operating mechanisms for waste outlets inside gatehouse

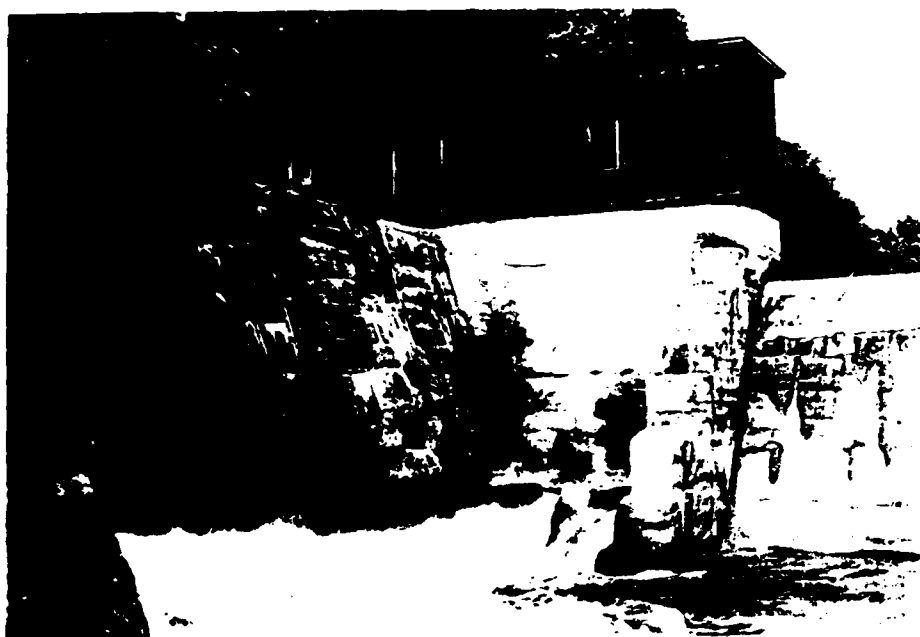
7. Deteriorated concrete walls above and adjacent to waste outlets

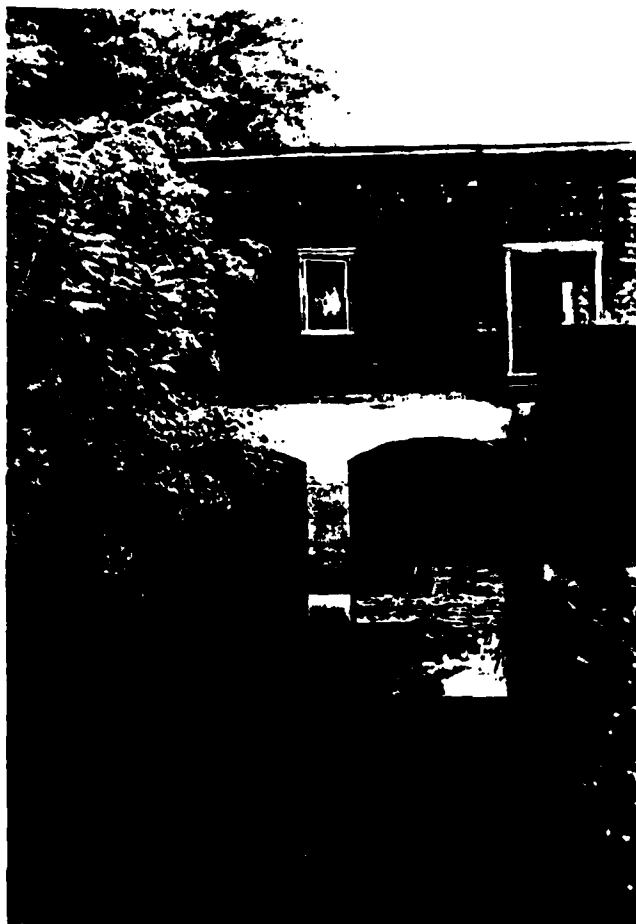
The right concrete power channel training wall is in good condition with minor deficiencies noted, Photo No. 9. The left training wall is in a deteriorated condition, Photo No. 10. There is spalling and erosion of concrete. The joints have deteriorated and spalled and contain some brush growth. The surfaces of the wall have cracking and efflorescence present.

9. Head gate outlets  
at entrance of  
channel to down-  
stream power  
station

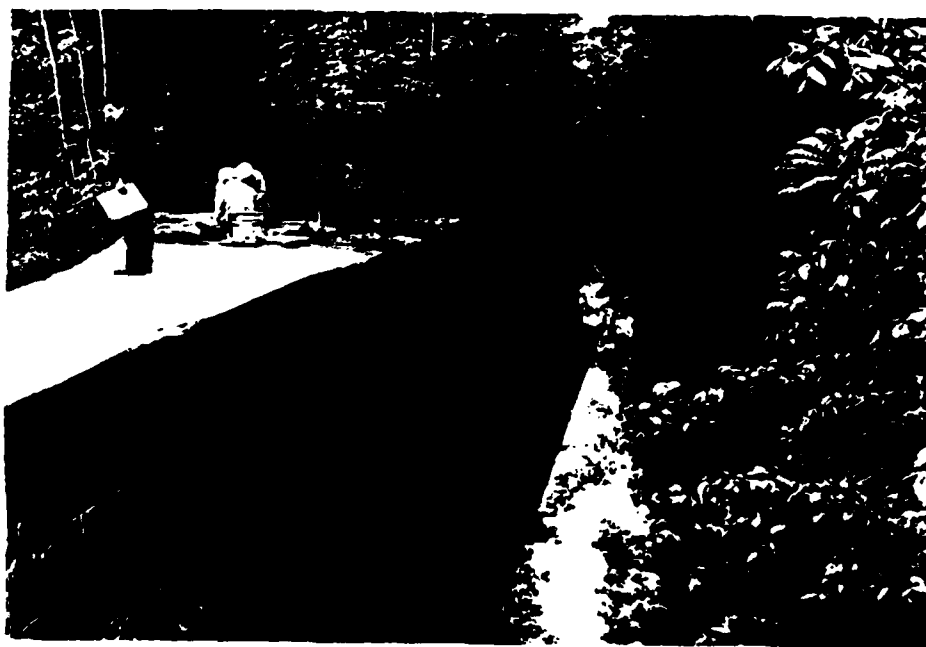
The power channel is a heavy stone-lined trapezoidal channel which, in general, is in good condition. However, in one area on the right side downstream of the concrete training wall, the side slope was collapsed into the channel, Photo No. 10.

10. Left training wall of channel to power  
station. Note rockfall where right channel  
wall has collapsed
